CANADIAN CENTRE
FOR **FISHERIES**
INNOVATION

COMMERCIAL EVALUATION OF A ROPE ON COMMAND
(ROC) FISHING SYSTEM FOR THE NEWFOUNDLAND AND
LABRADOR LOBSTER AND CRAB FISHERIES

March 31, 2023

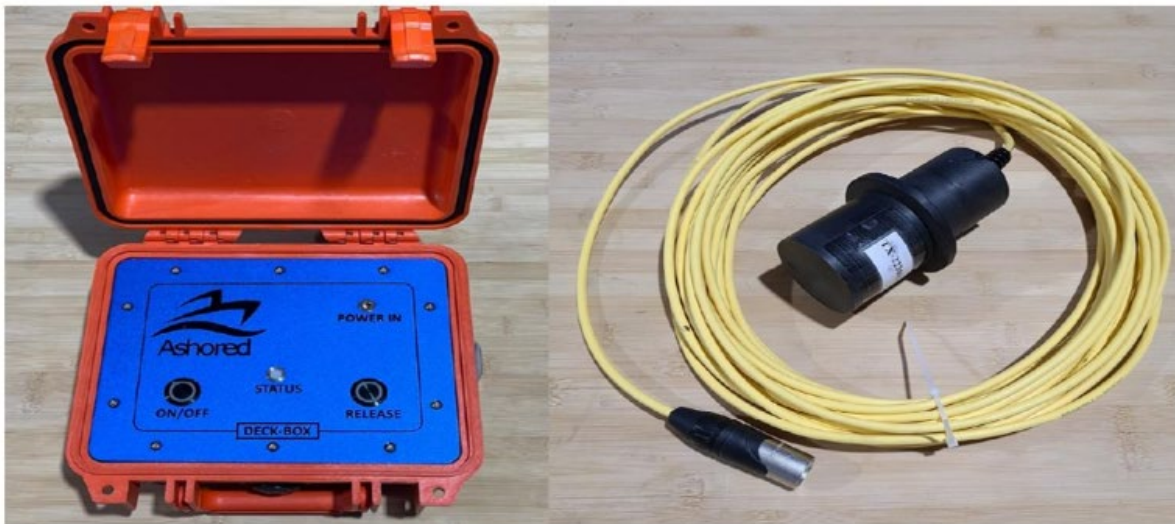
Figure 2 - Software

Ashored has developed ATLAS, an intuitive suite of software and hardware that tracks the location, inventory, connection, and ownership of a user's fishing gear. Super Tags, Smart Tags, and sensor arrays collect data and ATLAS+ software automates and displays this information in a convenient and actionable manner. MOBI's software and related system technology can be seen in the figure above.

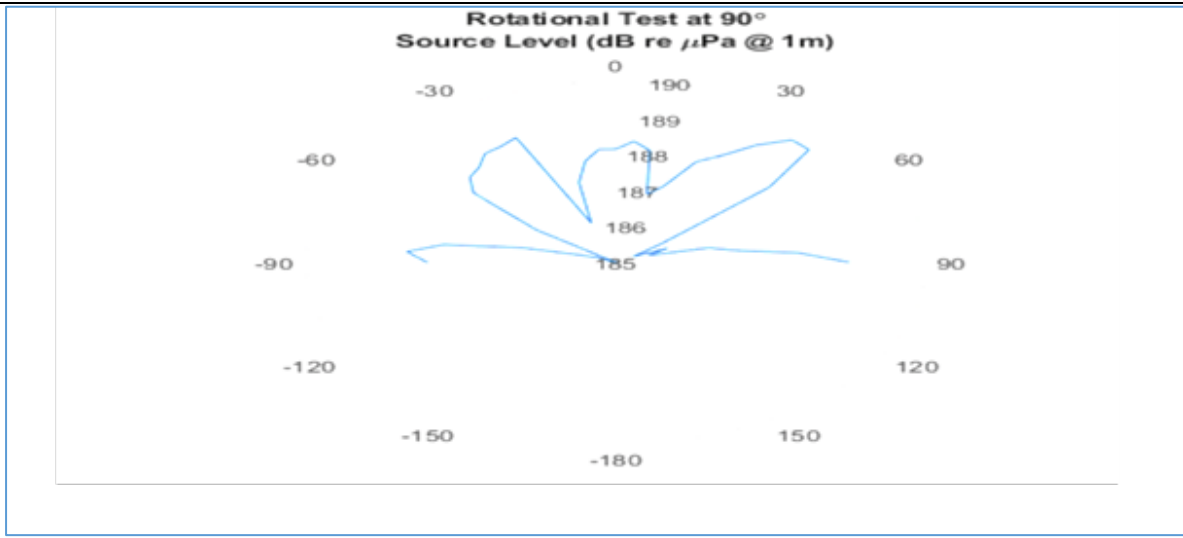
Figure 3 – Acoustic Tank Rotation Test Result

The MOBI transducer was mounted in an articulated holder at an optimal location in the Acoustic Tank to allow a reasonable "free field" window of time to make the required measurements. For these tests, the MOBI transducer unit was driven at the frequencies and intensities generated by the MOBI transducer drive electronics, and the mounting arrangement allowed for rotation of the unit to fully describe its output level from all directional aspects. The calibrated hydrophone was mounted 1m from the MOBI transducer to directly receive the generated signals within the "free field" time window of approximately 1.33 msec. Measurements were taken at both azimuth and elevation covering a hemispherical surface describing all possible vessel approach angles to a MOBI unit when deployed.

The test results documented a source level consistent with a range in seawater in excess of a 1 km, and a variation of intensity over the hemispherical space of 3dB within +/- 45 degrees of vertical, and +/- 5dB within +/- 60 degrees of vertical. These results confirm the potential for the MOBI unit to perform its intended role with no deficits noted (See Figure 3 – Acoustic Tank Rotational Test). Figure 3 outlines the MOBI unit transducer output data. Zero degrees represents the water column, and the angles are elevations. Azimuth intensities (not show for full rotation) are constant with 1dB over 360 degrees, as expected for a uniform cylindrical transducer element.

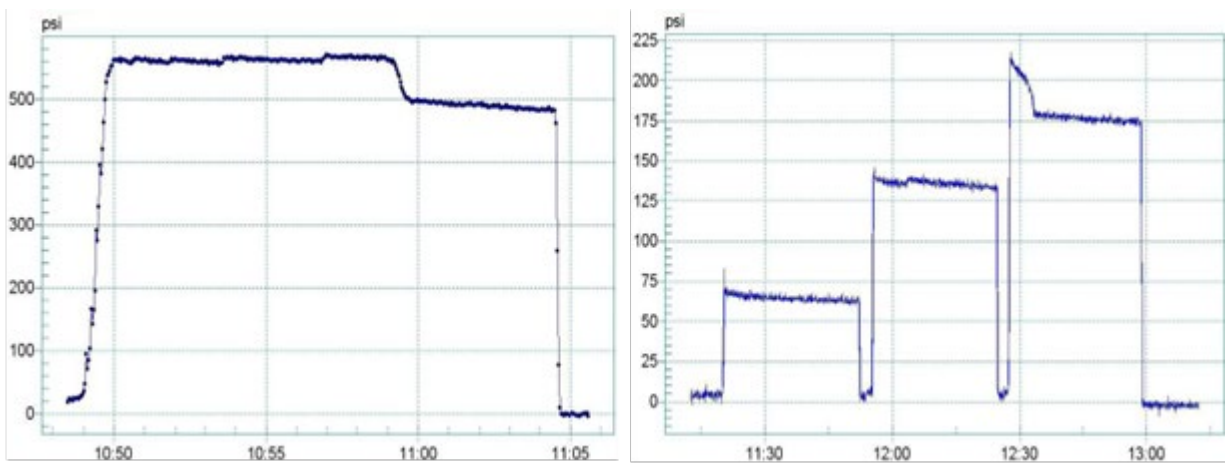
Figure 9 – Pressure Chamber results – water penetration

Ashored had indicated that the MOBI unit had never been tested at depths needed to fish snow crab. After initial testing it was quickly realized that water was penetrating the MOBI units, and the units were failing. The testing indicated changes in pressure inside the chamber and gains in the total weight of the MOBI units after testing. The penetration of water into the unit resulted in a pressure drop inside the pressure chamber. Aligned with the results seen in the pressure chamber testing, early results in the field and in the flume tank in May 2022 also saw water penetration at depths much shallower than needed for crab fisheries.

During field and flume tank testing, visual observations showed water escaping from around the transducer, charging lugs, and LED light. Failures in the MOBI units from the pressure chamber testing were not visually evident, however, the weight of the units changed with units weighing more after testing. The weight gain indicated water had penetrated the system and was causing significant issues with reliability and normal operations. As well, from the pressure sensor, it was easy to see the pressure drop, which also indicates the failure of the MOBI system and water penetration. Figure 9 below shows pressure chamber results (y axis outlines the pressure, while the x axis shows the time the unit was at depth). The graph on the left outlines a MOBI unit failure in less than 10 minutes at a depth of 400m (582psi). After the MOBI unit was removed from the pressure chamber, weight increased from 3915 grams to 3950 grams. This indicates that 35 grams of water had penetrated the MOBI unit during the test. The graph on the right shows interval testing where MOBI unit failed at 215 psi (150m) after cycling through shallower depths (50-100m) for half hour intervals. There was also a change in the weight of the MOBI unit, gaining 10 grams.

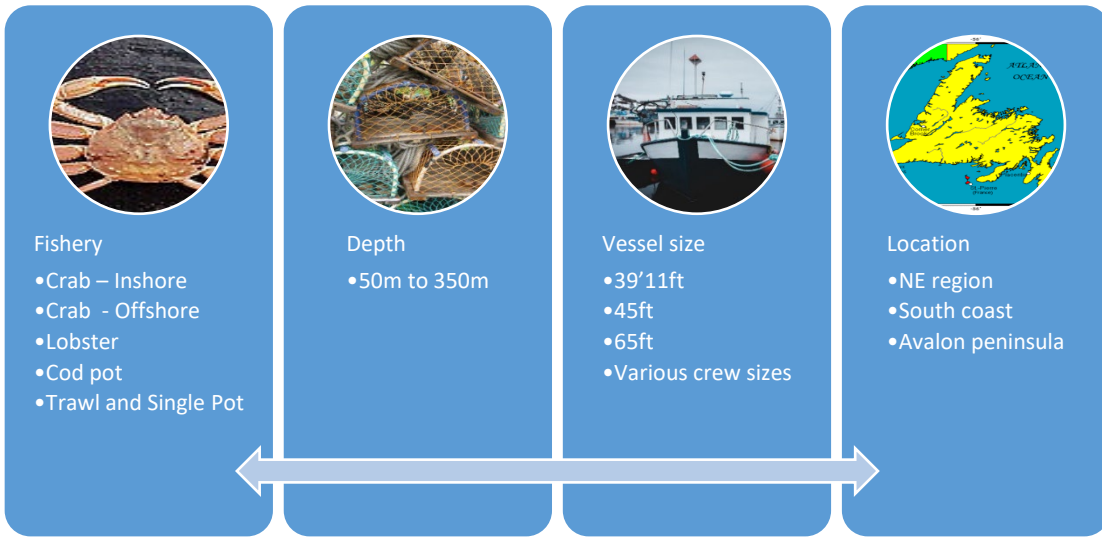
Figure 15 – Summary of Testing Variables

- Commercial testing with Harvesters was instrumental to providing insight into other aspects of the equipment’s behaviour under the sea conditions experienced in traditional crab harvesting depths off the coast of Newfoundland and Labrador.
- Commercial harvester field-testing began in September and continued through to March 2023. Seven harvester vessels were chartered in areas of Petty Harbour, Grand Bank, Fogo, and Conception Bay South, NL.
- The harvester trials included lobster, crab (inshore and deep sea) and cod pot fisheries. The trials encompassed various conditions and variables, as summarized in the graphic below as well as elaborated on in the detailed results below.

- As testing progressed, significant collaboration with Ashored and eSonar continued to take place. Remediations to the product (cage stability on seabed, cage size, battery functionality, connectivity enhancements, buoy sizes, key design), were necessary to achieve the harvester testing stage objectives.
- Significant product upgrades/fixes were made including resolutions to water penetration, key shape, and firmware/ software maintenance. In addition, the standard operating procedures were being refined to learn the appropriate release of the cage into the water to prevent the lid from early release.
- Harvester testing provided valuable insight for both the technology development as well as adoption considerations to enable successful change to fishing operations.

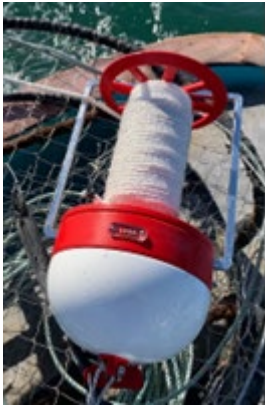
Puget Buoy is a US-based company with a product in the development and testing stages. Puget Buoy has developed a new type of pop-up buoy; one that prioritizes speed, durability, and space efficiency at a low economical price for commercial fishermen. A session was held with Puget Buoy at the Marine Institute. The product was trialed and observed in the flume tank and a productive discussion was held with respect to the conditions that the product would be required to operate in to meet the needs of the crab fishery in the water of Newfoundland and Labrador.

Puget Buoy's goal is to provide a product to the industry that is based around a spooler varying in size depending on the depth of the operation to encompass the rope type and length required. This product requires the harvester to acquire a custom spooling unit to be applied to the deck.

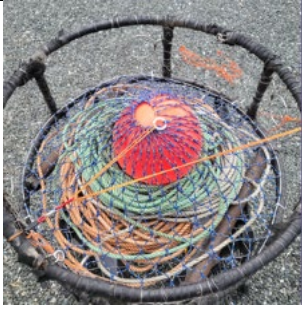
Guardian Ropeless – Sub Sea Sonics Trawl Sled

Guardian and Sub Sea Sonics have partnered to bring a unit to market to benefit the whale safe gear issue. Their product, Guardian Sled, is a high-capacity line and buoy retention system that doubles as an end anchor for multi-trap trawls or groundlines. It has been successful in shallow water fisheries and starting to gain positive data in deeper water as well. The unique capability of this unit raises CCFI interest with respect to the snow crab industry as the shape is adaptable to the size/ shape that works best for the fishery it is being used in. The round version responds to the suggestions of snow crab harvesters in this project who suggested such a model would be more adoptive and integrate into current practices easier.

The reset process also appeared simplified. It is facilitated by having an empty cage ready to spool the rope into as it comes off the hauler. The float and netting are then secured on top, and the cam arm is reset again. The netting design and reset procedure aligns well to the skills and products that the fishers currently use/ have typical experience with. From that perspective, troubleshooting issues with the mechanical design and innovatively resolving those issues seemed reasonable using the tools, skills, and equipment fishers would typically have today.
